13th Computer Control for Water Industry Conference, CCWI 2015

Measurements and analysis of cavitation in a pressure reducing valve during operation – a case study

Bogumil Ulanicki^{a,*}, Lorenzo Picinali^b, Tomasz Janus^a

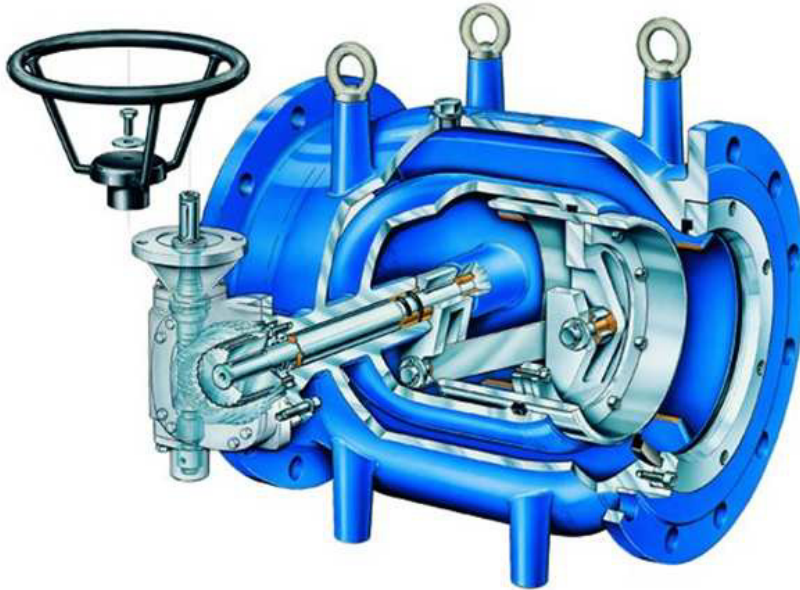
Fig. 1: Cross-section of the VAG plunger valve.
