Lead Apron Inspection Using Infrared Light: A Model Validation Study

Sarah E. McKenney, PhD, Hansel J. Otero, MD, Stanley T. Fricke, PhD

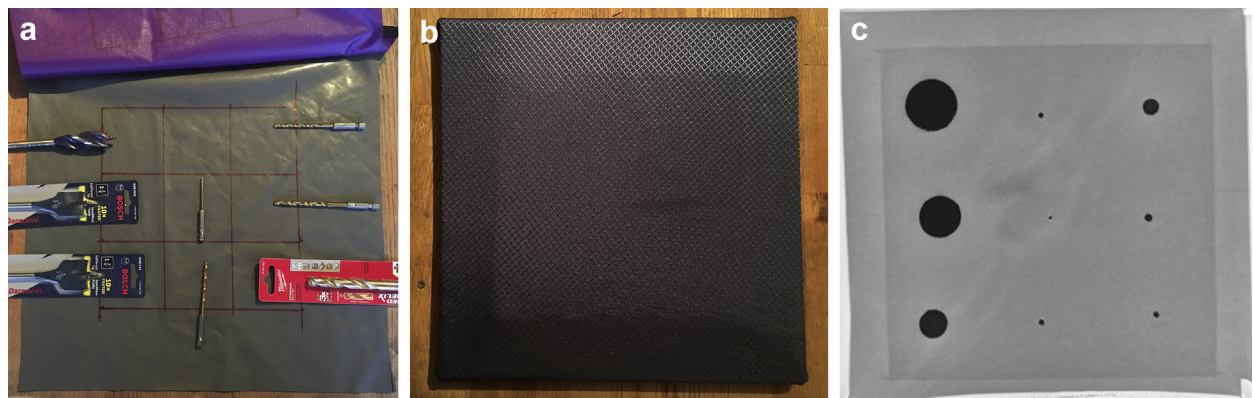
Fig 1. Construction of the detection lead apron phantom for tactile and infrared inspection. (a) Lead apron open exposing 0.5 mm lead-equivalent material (gray) and the backing of the outer apron fabric (purple). A grid is drawn on the material with the drill bit size layout. (b) The shielding material is sandwiched between the apron’s original protective fabric and stapled to a frame. A piece of drywall that is thicker than the frame is placed under the frames cut out to put tension on the fabric and create an “ideal” tactile sensory environment for defect discovery. (c) Radiograph of lead apron phantom.

To assess the defect detection performance, a lead apron phantom was created. A series of nine holes with increasing diameter were drilled in lead-equivalent apron material from a discarded lead apron (5-mm lead equivalent at 85 kVp, West Medical Inc; see Fig. 1a). Upon removing the enclosing apron fabric from the discarded apron, it was discovered that the lead-equivalent material consists of two sheets to form a bilayer, rather than a single sheet (see Appendix 1). Both sheets of the bilayer were used for the phantom.

and a sheet of drywall was placed under the frame to allow the edges of the holes to be detected (see Fig 1b).

The defects of the lead apron phantom were first imaged and measured from a computed radiography (CR) radiograph obtained with an abdomen technique (73 kVp and 1.3 mAs) at a source-to-image distance (SID) of 100 cm using a radiography or fluoroscopy system (EasyDiagnost Eleva, Philips Medical Systems, Hamburg, Germany). The image had a pixel spacing of $0.144 \text{ mm} \times 0.144 \text{ mm}$. The diameters were measured in both the transverse and longitudinal direction. The measured diameters are larger than the bit size (Table 1) due to the process of drilling the holes.
